Natural Gas Distribution

Cross Bore Safety

Pipeline Safety Seminar

**By: Mark Bruce, President,
Cross Bore Safety Association**

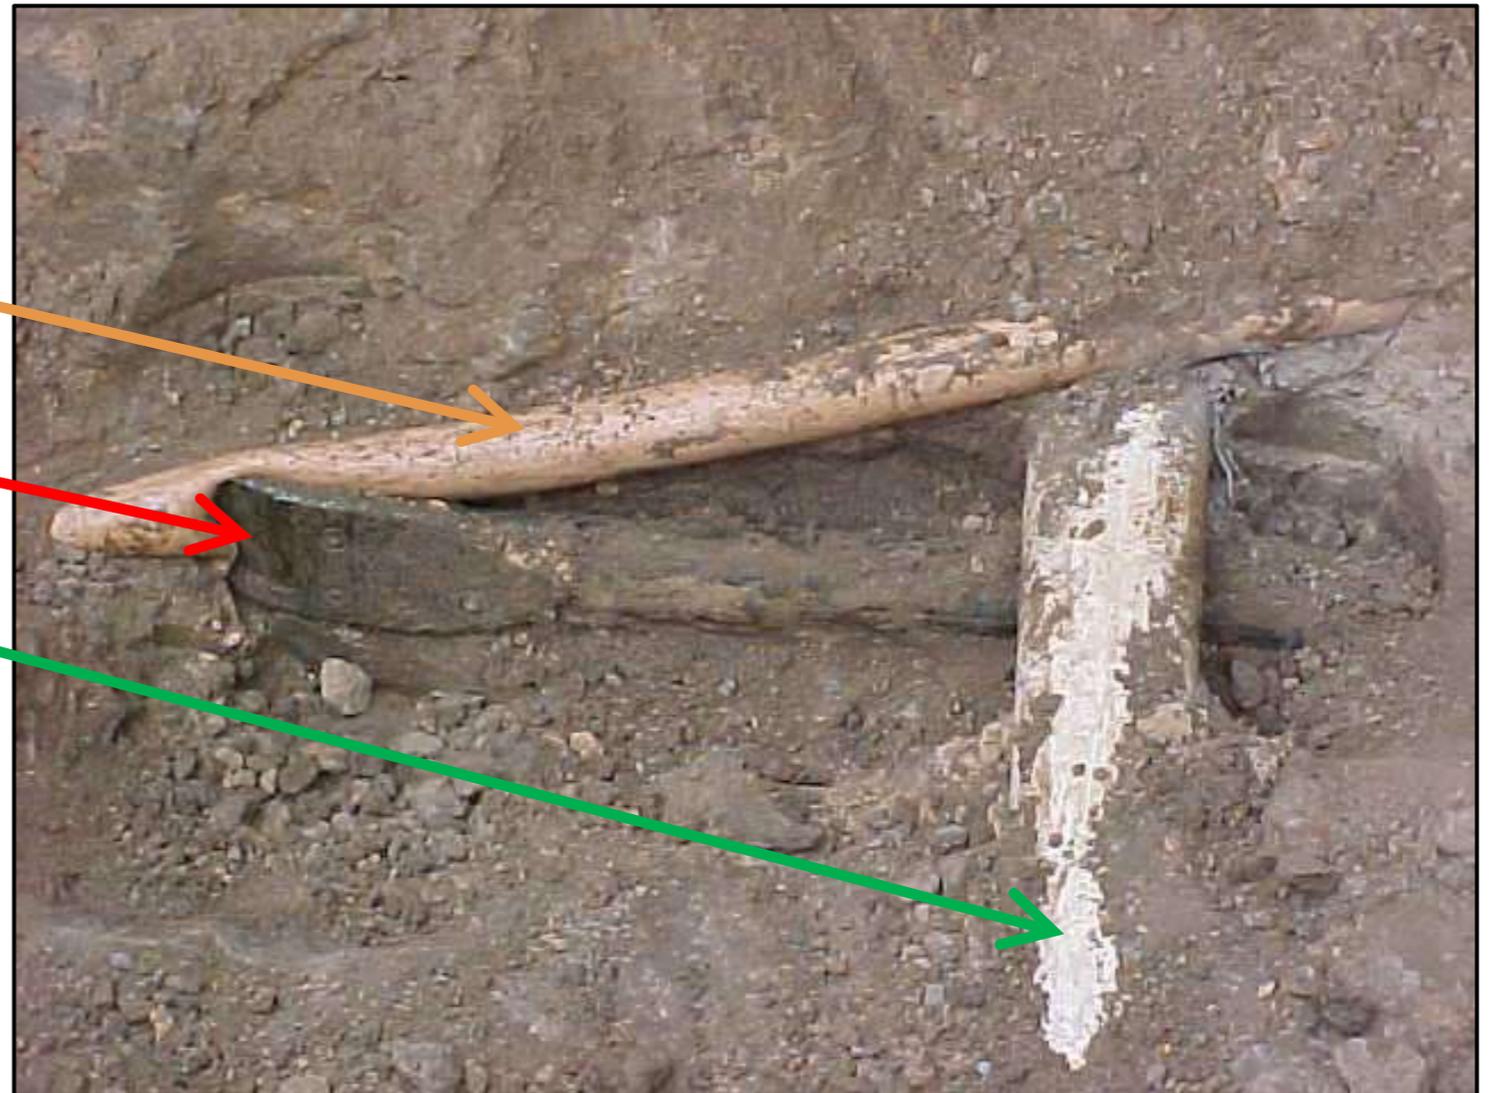
Class 2 Cross Bore

Gas line
HDD tool
Sewer to house

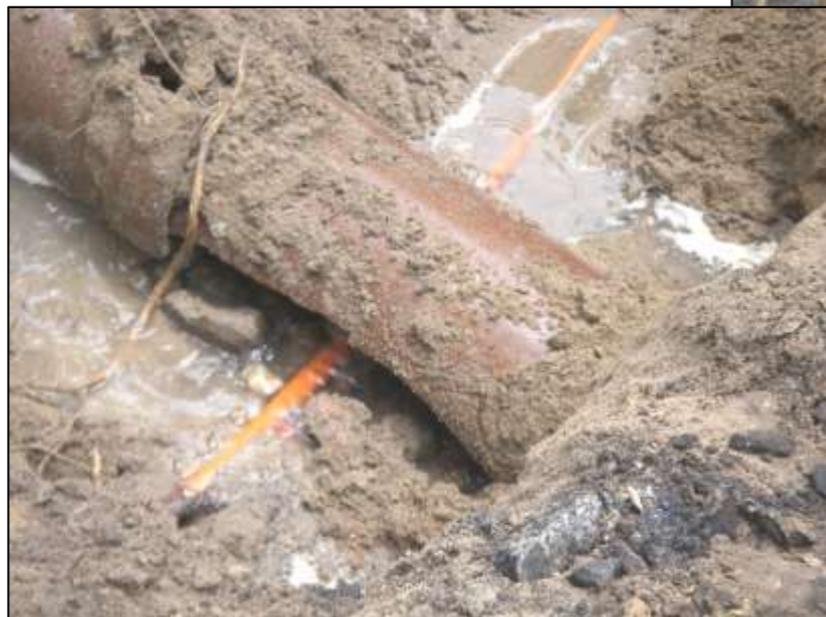
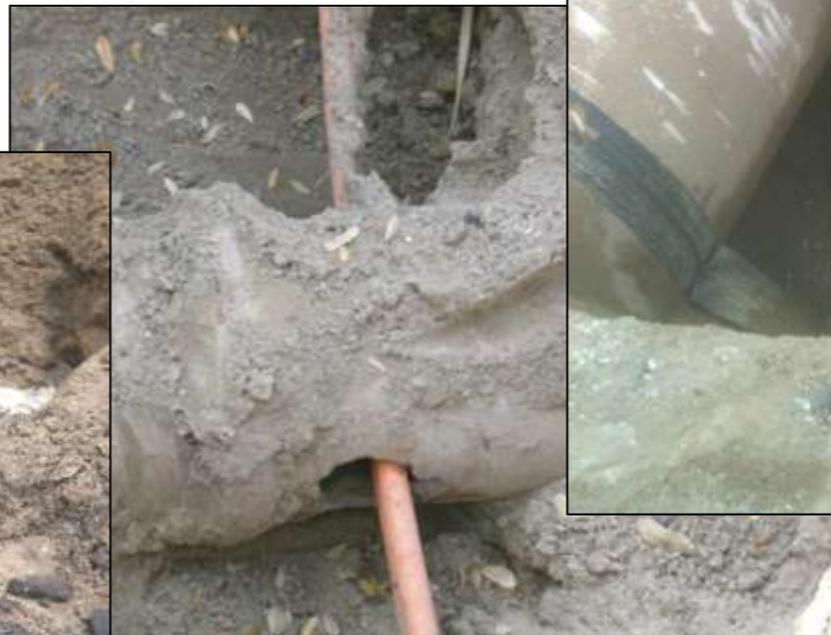
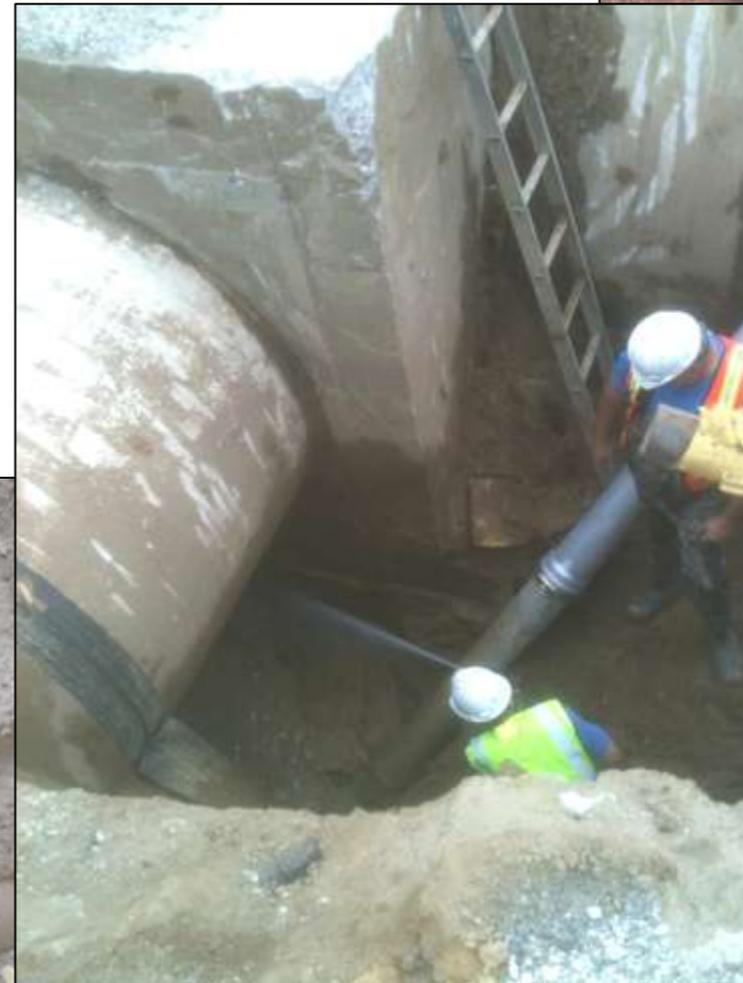
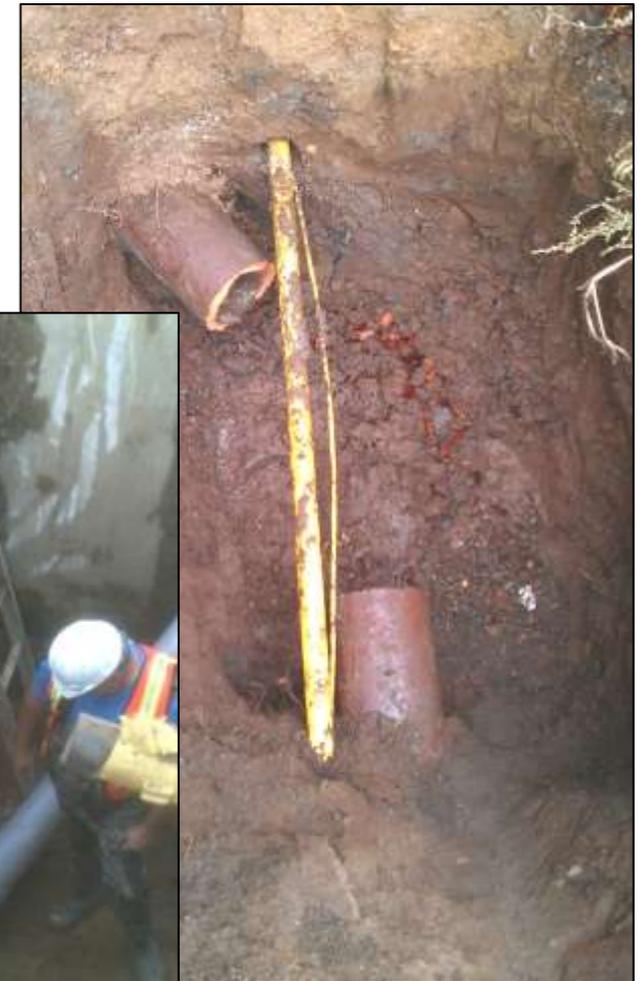
Cross Bore Required Repairs

- Gas cross bore repairs to sewers shown on this slide cost >\$150,000.
- EPA illegal pollution, fines
- Disruptive to community

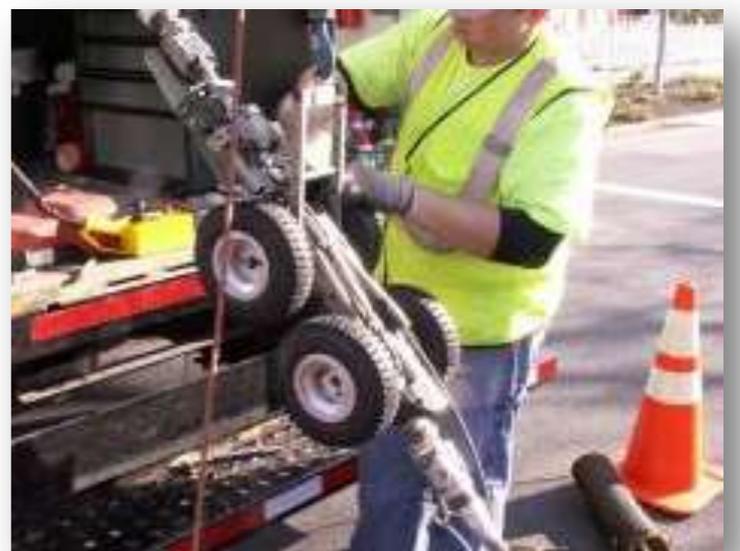
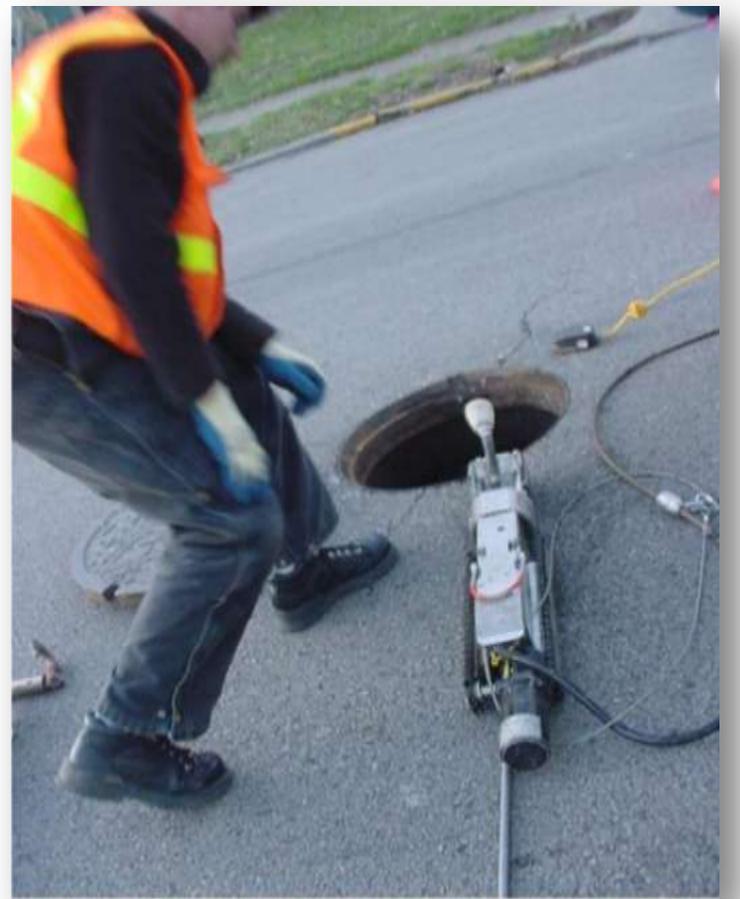
Mainline Cameras w/ Lateral Launch Camera

- Inspect mainline sewers for cross bores through manholes
 - 550 feet from manhole
 - Determines # of laterals, structures may have multiple
- Inspect lateral sewer up to 120 ft from sewer tap in good conditions

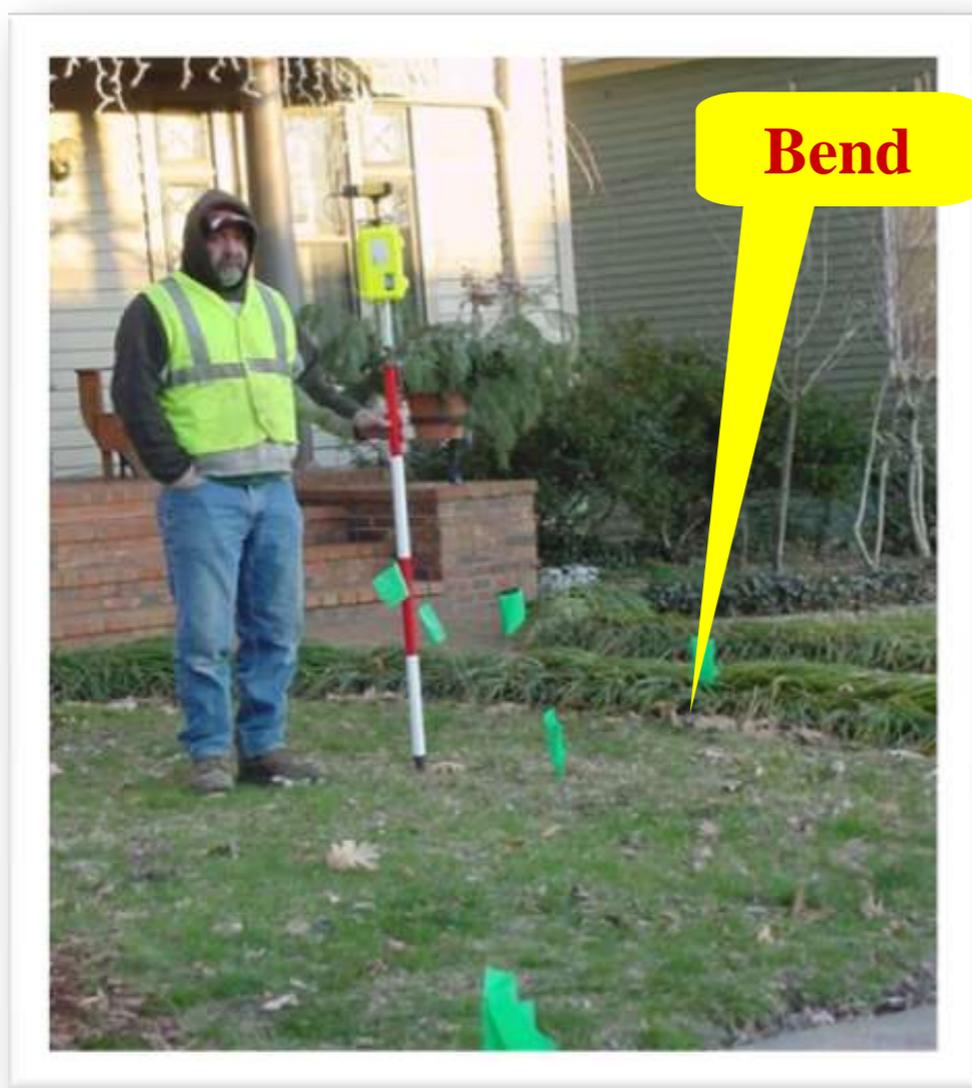
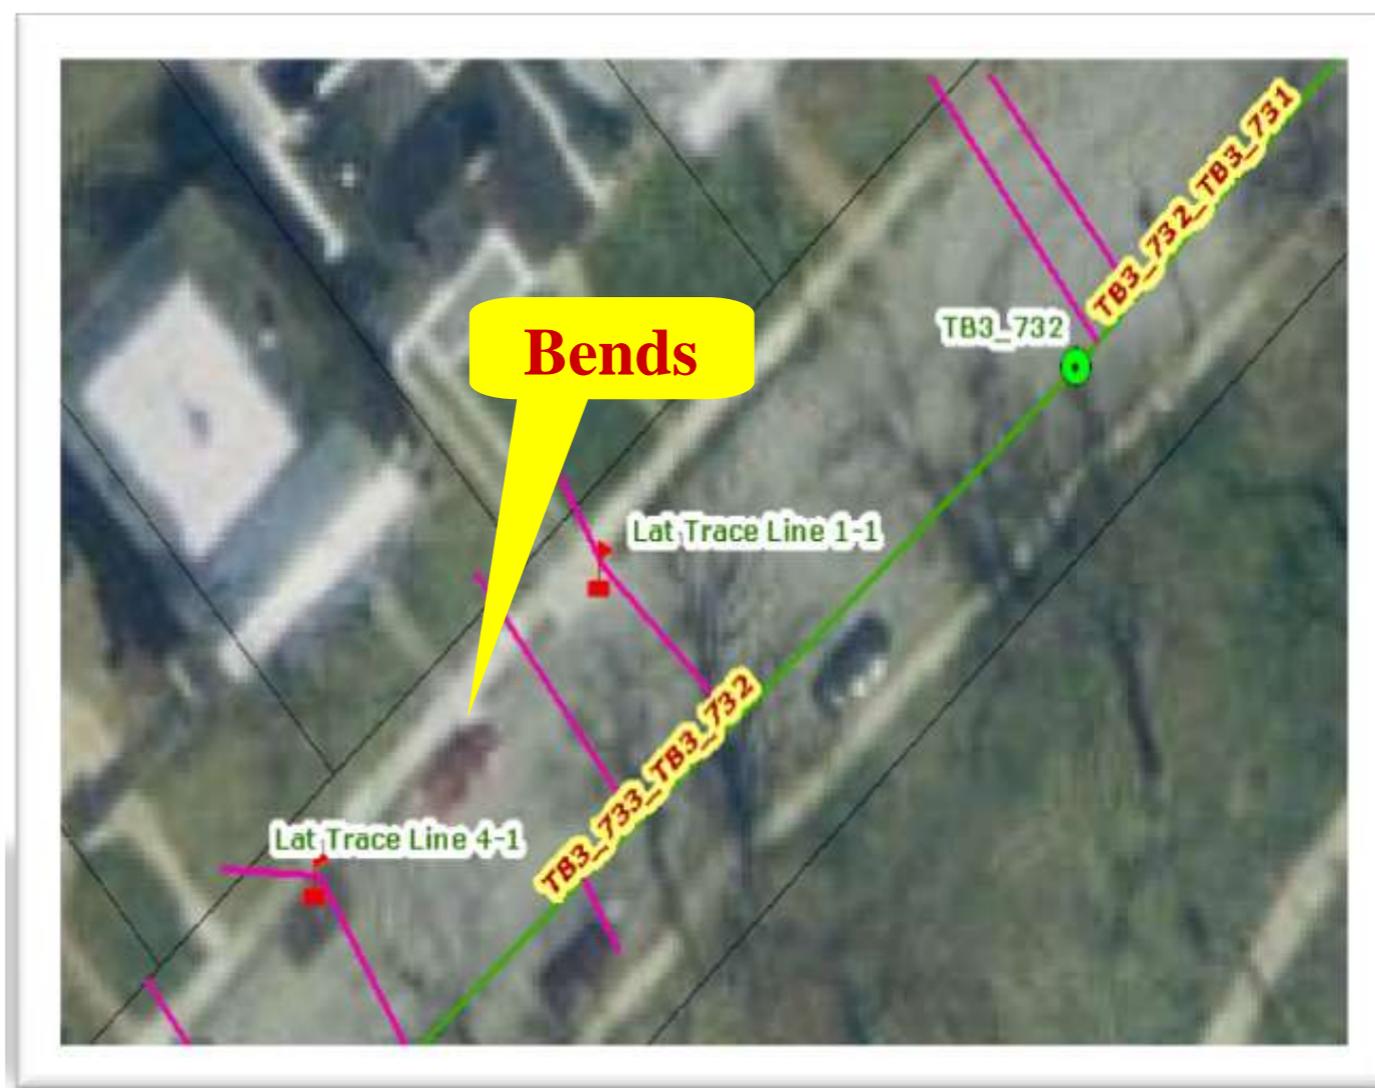
Lateral Line Traces could remain flagged / spray painted until Gas Line installation crews arrive...

This trace line has bends in the line...which are now reflected in GIS

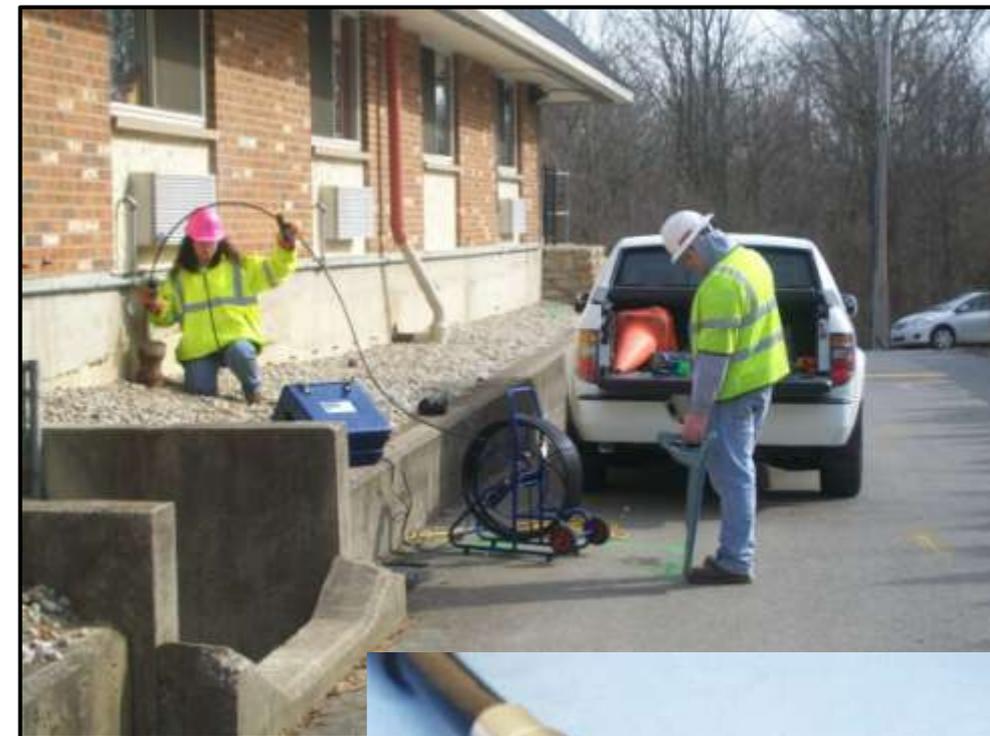
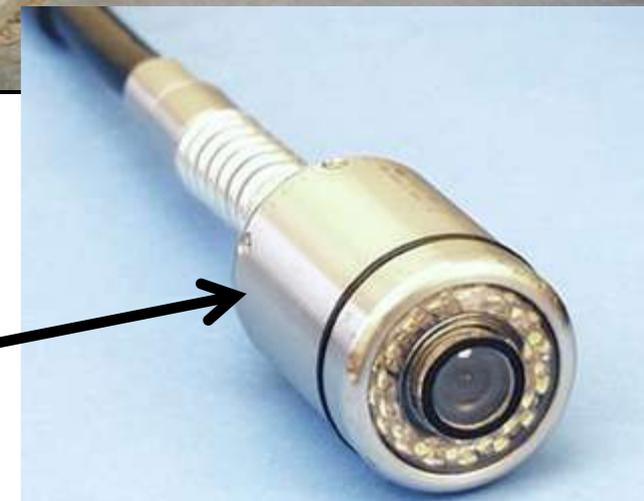
Push Cameras

- Manual push camera on stiff cable
- Distance to 200 ft or more of cable
- Used when mainline robotic cameras do not reach required limits of inspection
- Video, depth and GPS loaded into GIS mapping

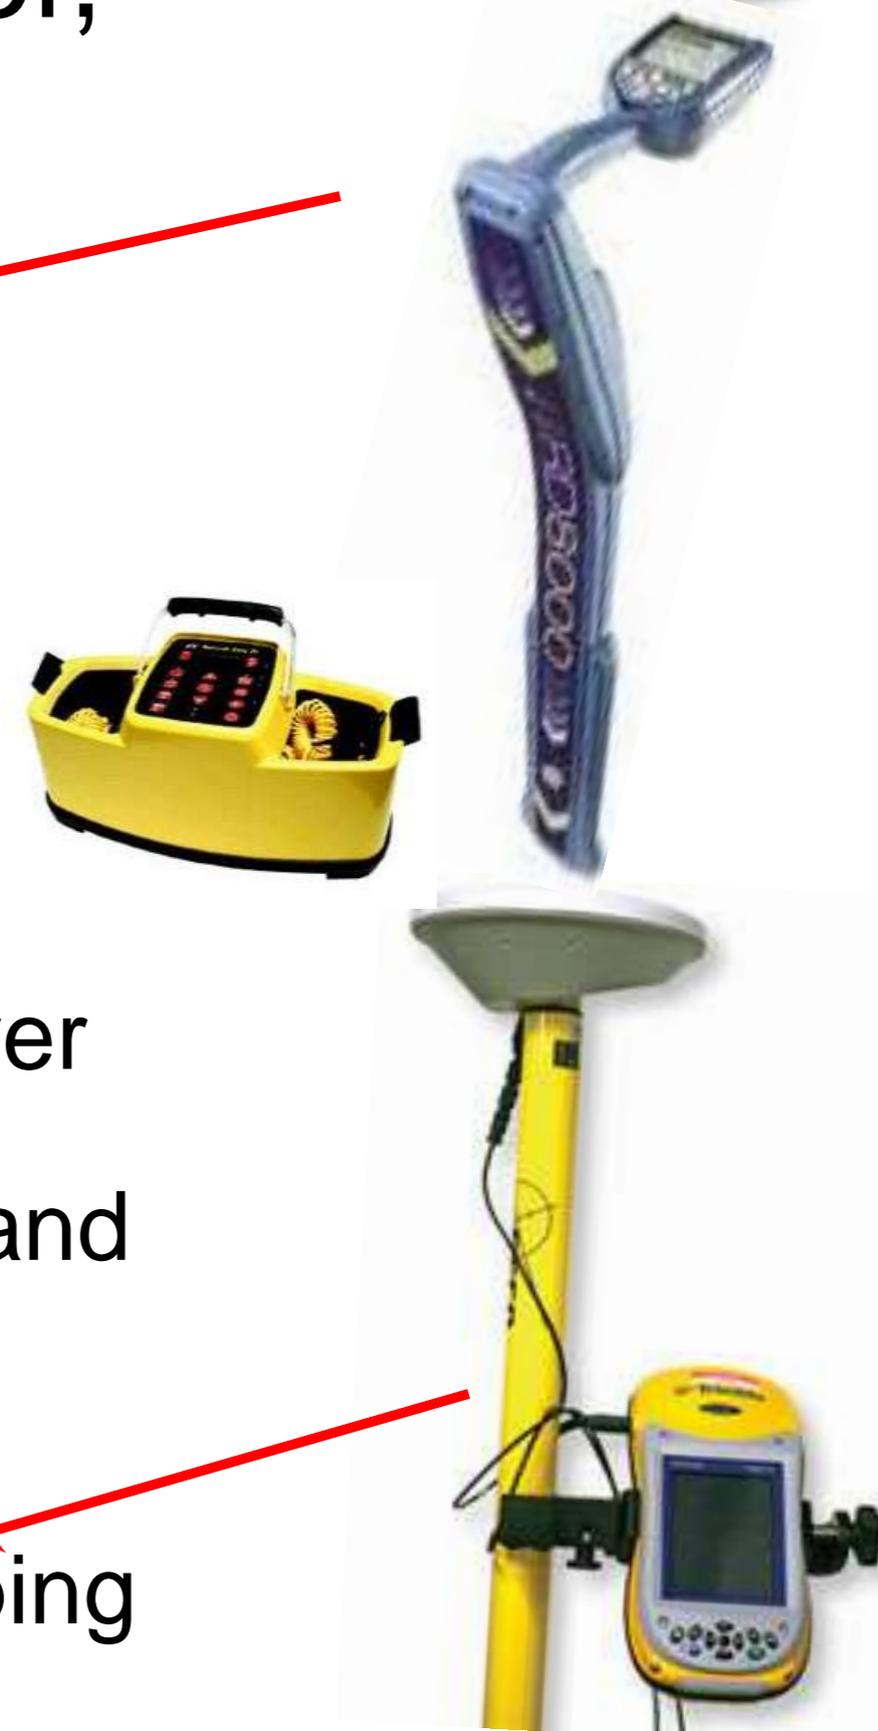
Sonde - Radio Frequency Transmitter & Camera

Locator, Frequency Generator, Sonde & GPS

- Locator - horizontal and vertical
- Sonde - (behind camera) transmits to above ground walk over receiver
- Frequency induced (energized) in tracer conductor transmits to receiver
- Receives signal determines depth and horizontal position of signal
- GPS records location for GIS mapping

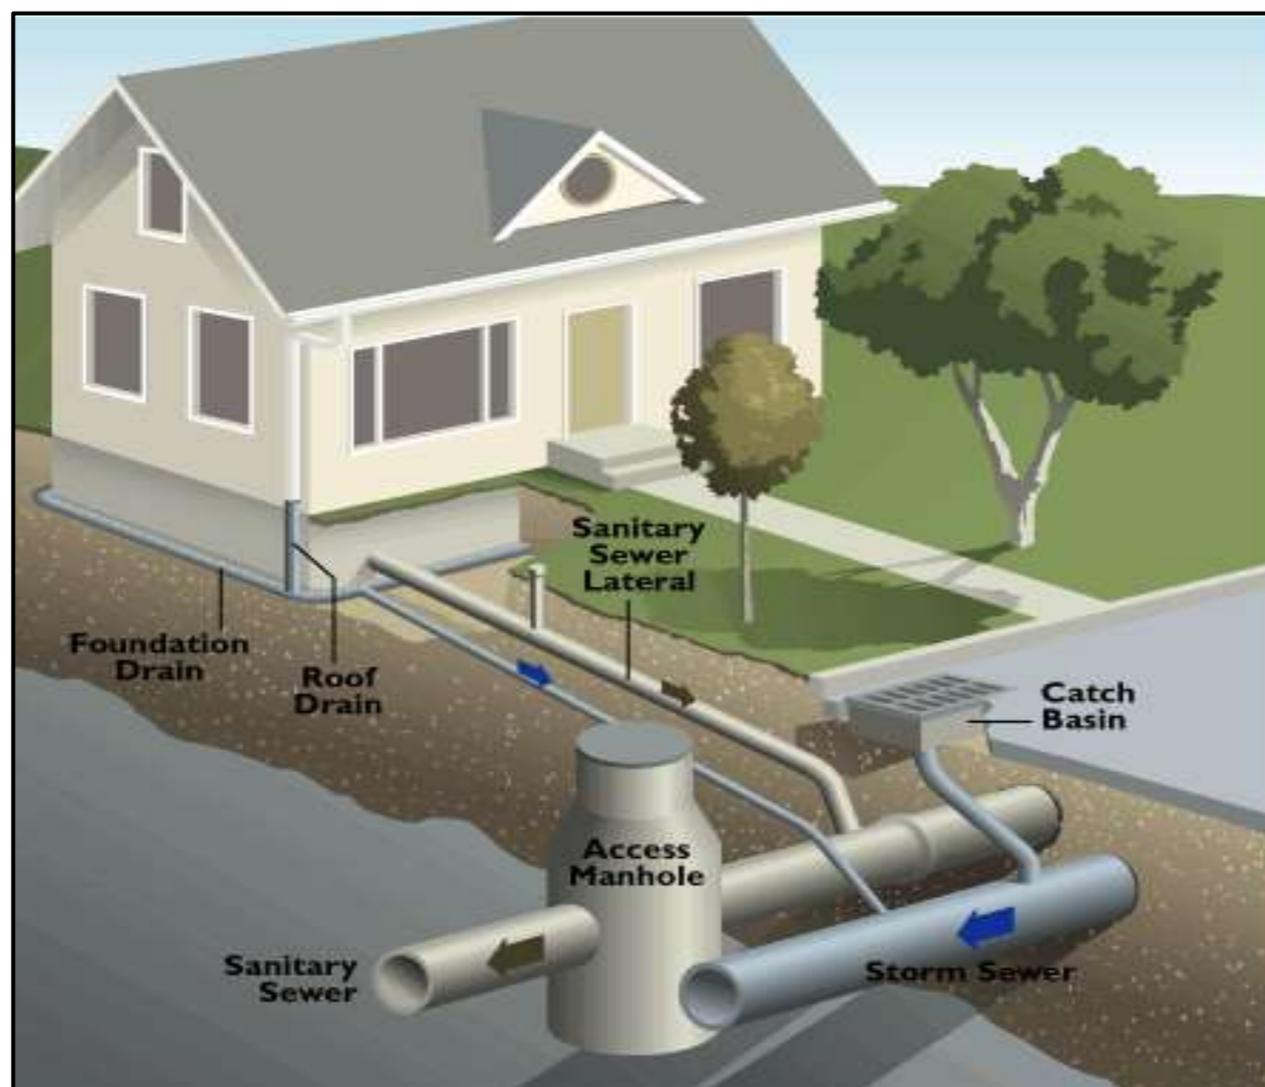
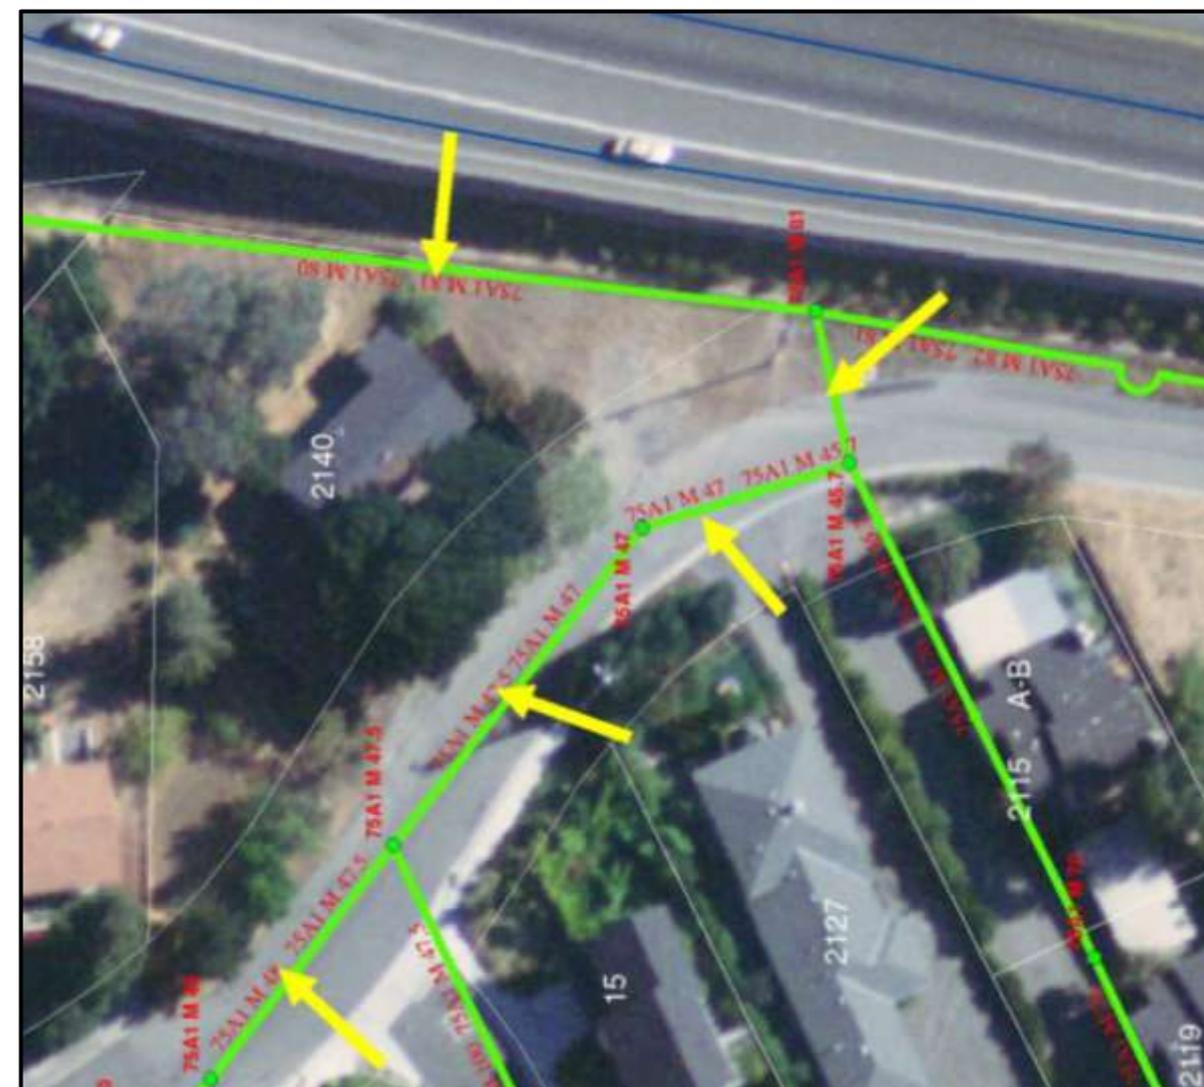
Residential Plumbing Connection to City Sewers

House with 5 mainline sewers on perimeter

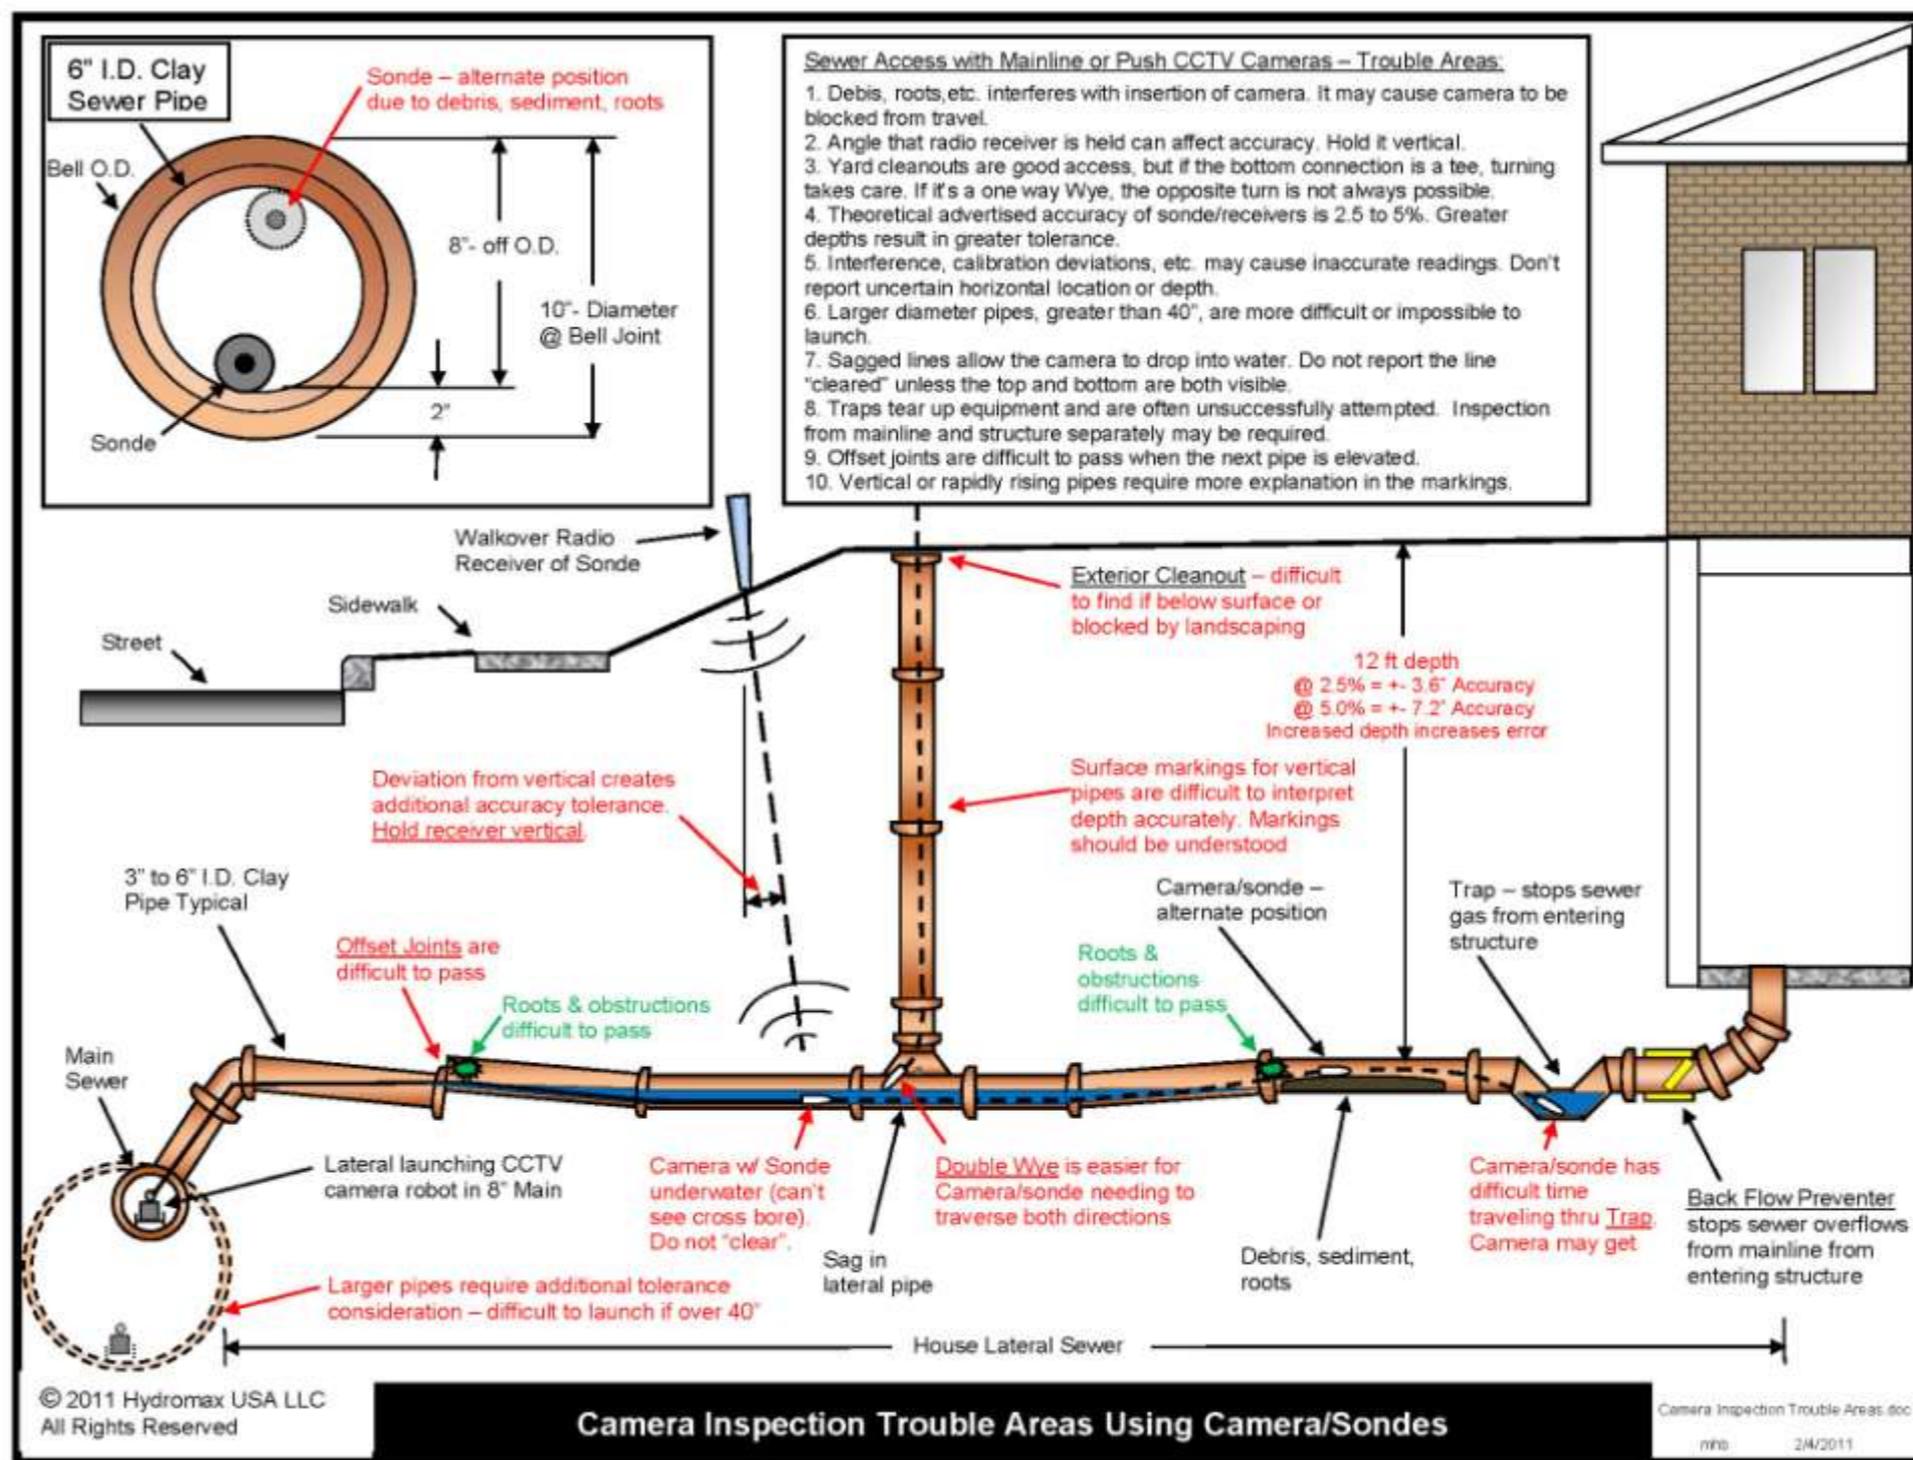
Camera Inspection Trouble Areas

- Water in sags
- Roots
- Sonde Angle
- Sonde Position
- Traps
- Back flow preventers

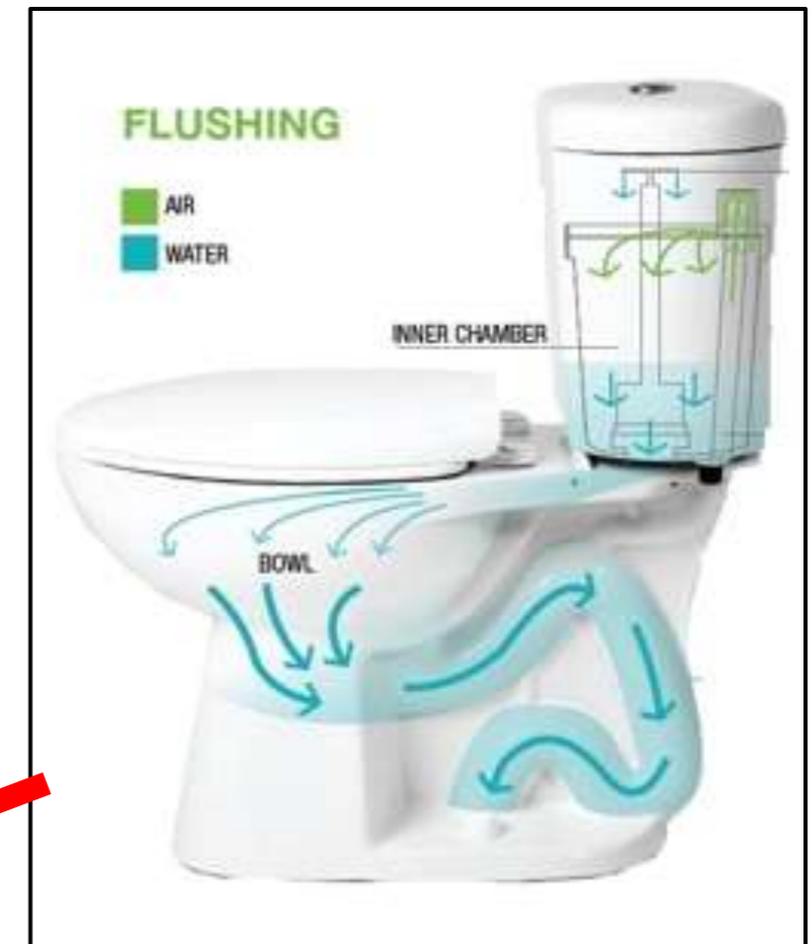
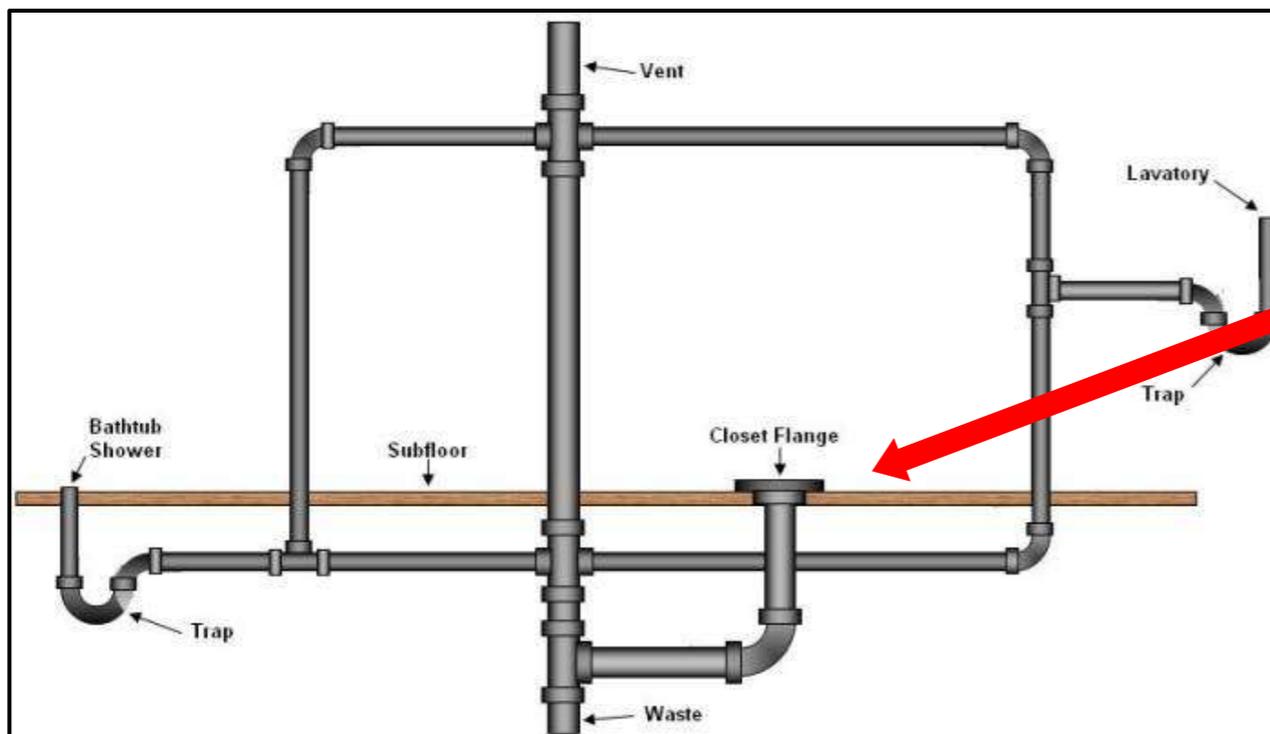
When Exterior Access is Limited or Pipes Impassable

- Interior access through pipe, roof vents or interior cleanouts
- Permission from owner

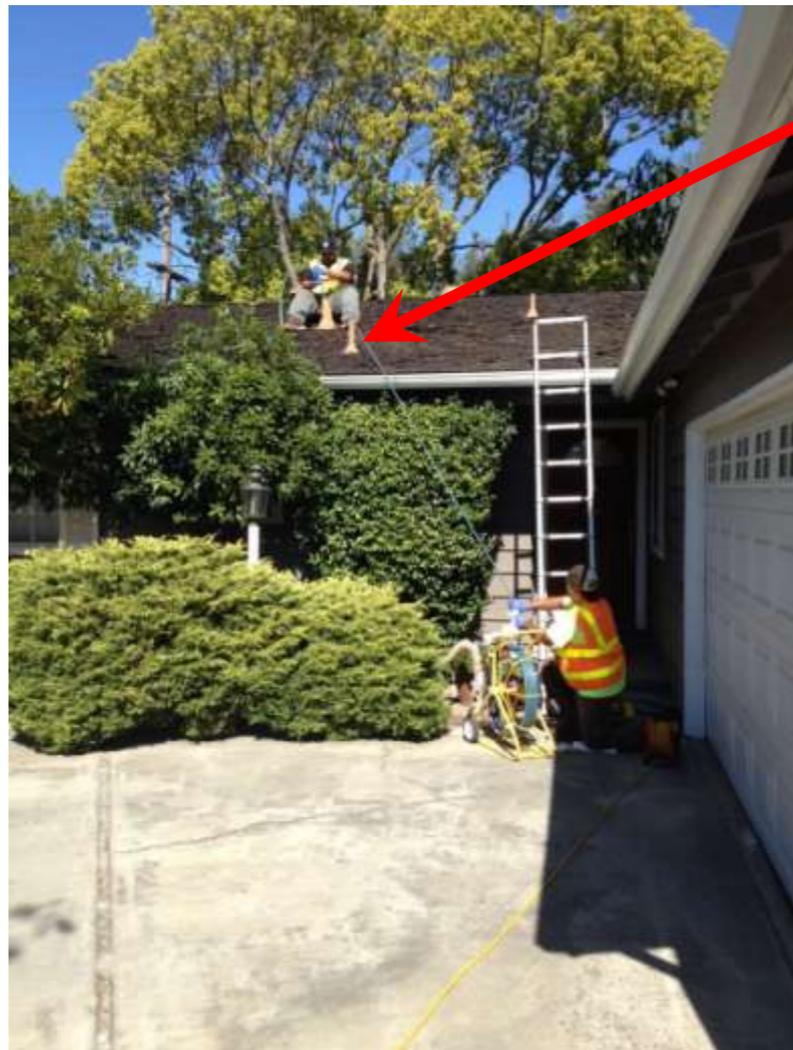
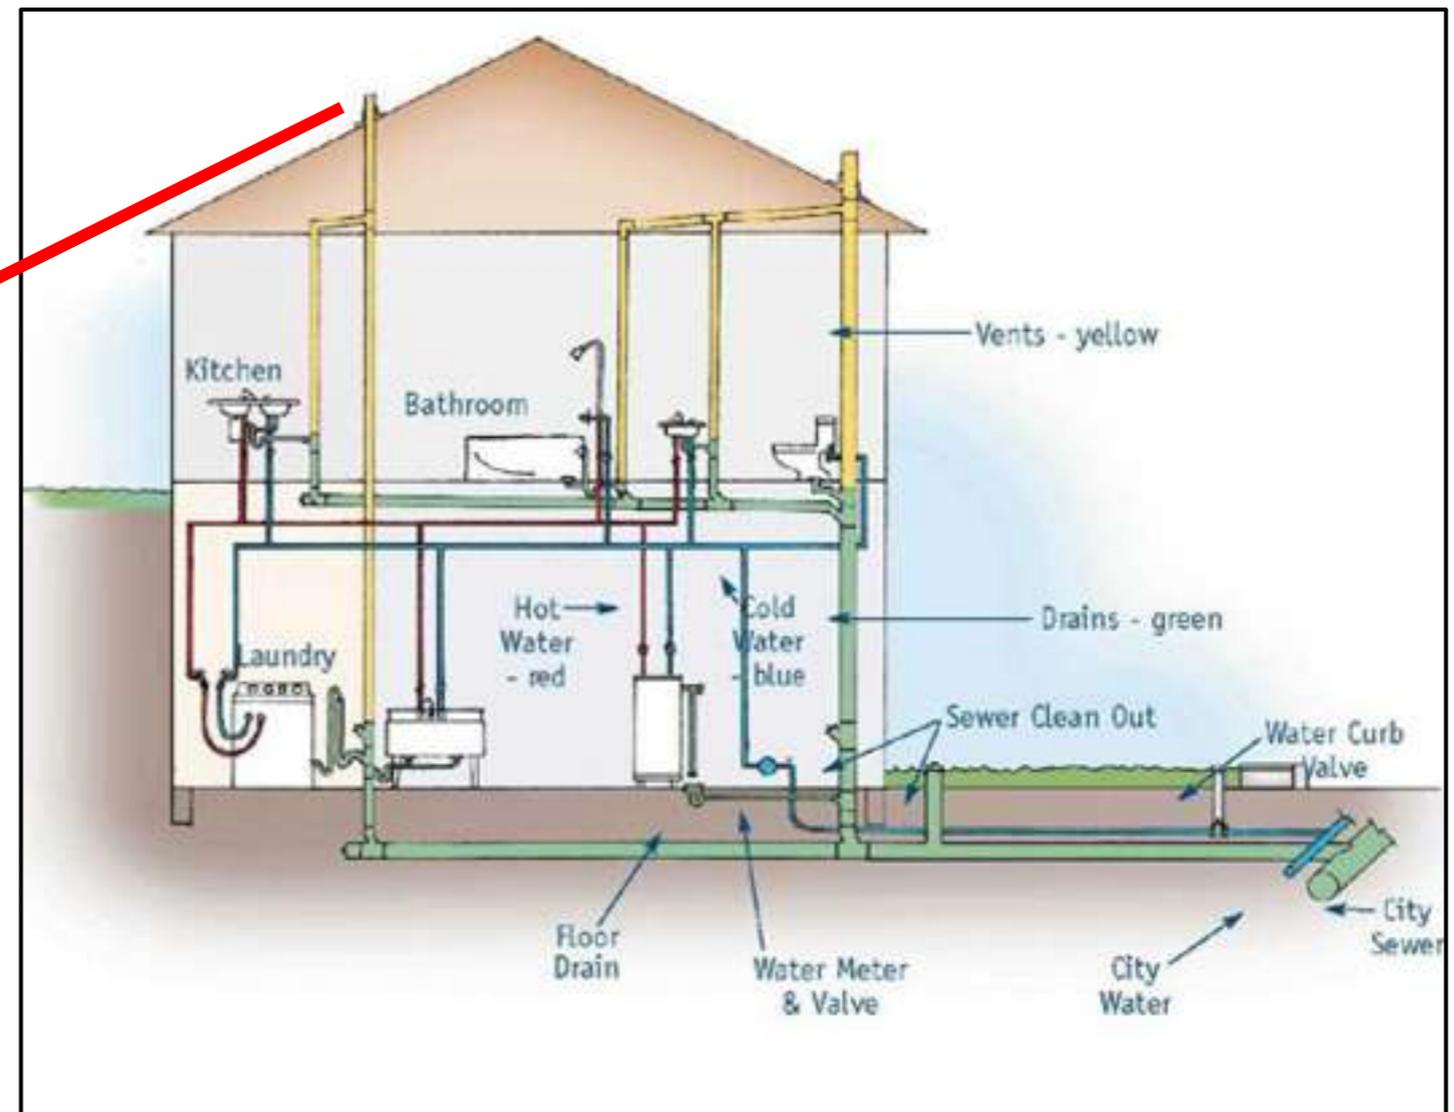
Roof Vent Access

- Usually only 1 story houses
- Permission from owner
- Protect from falls

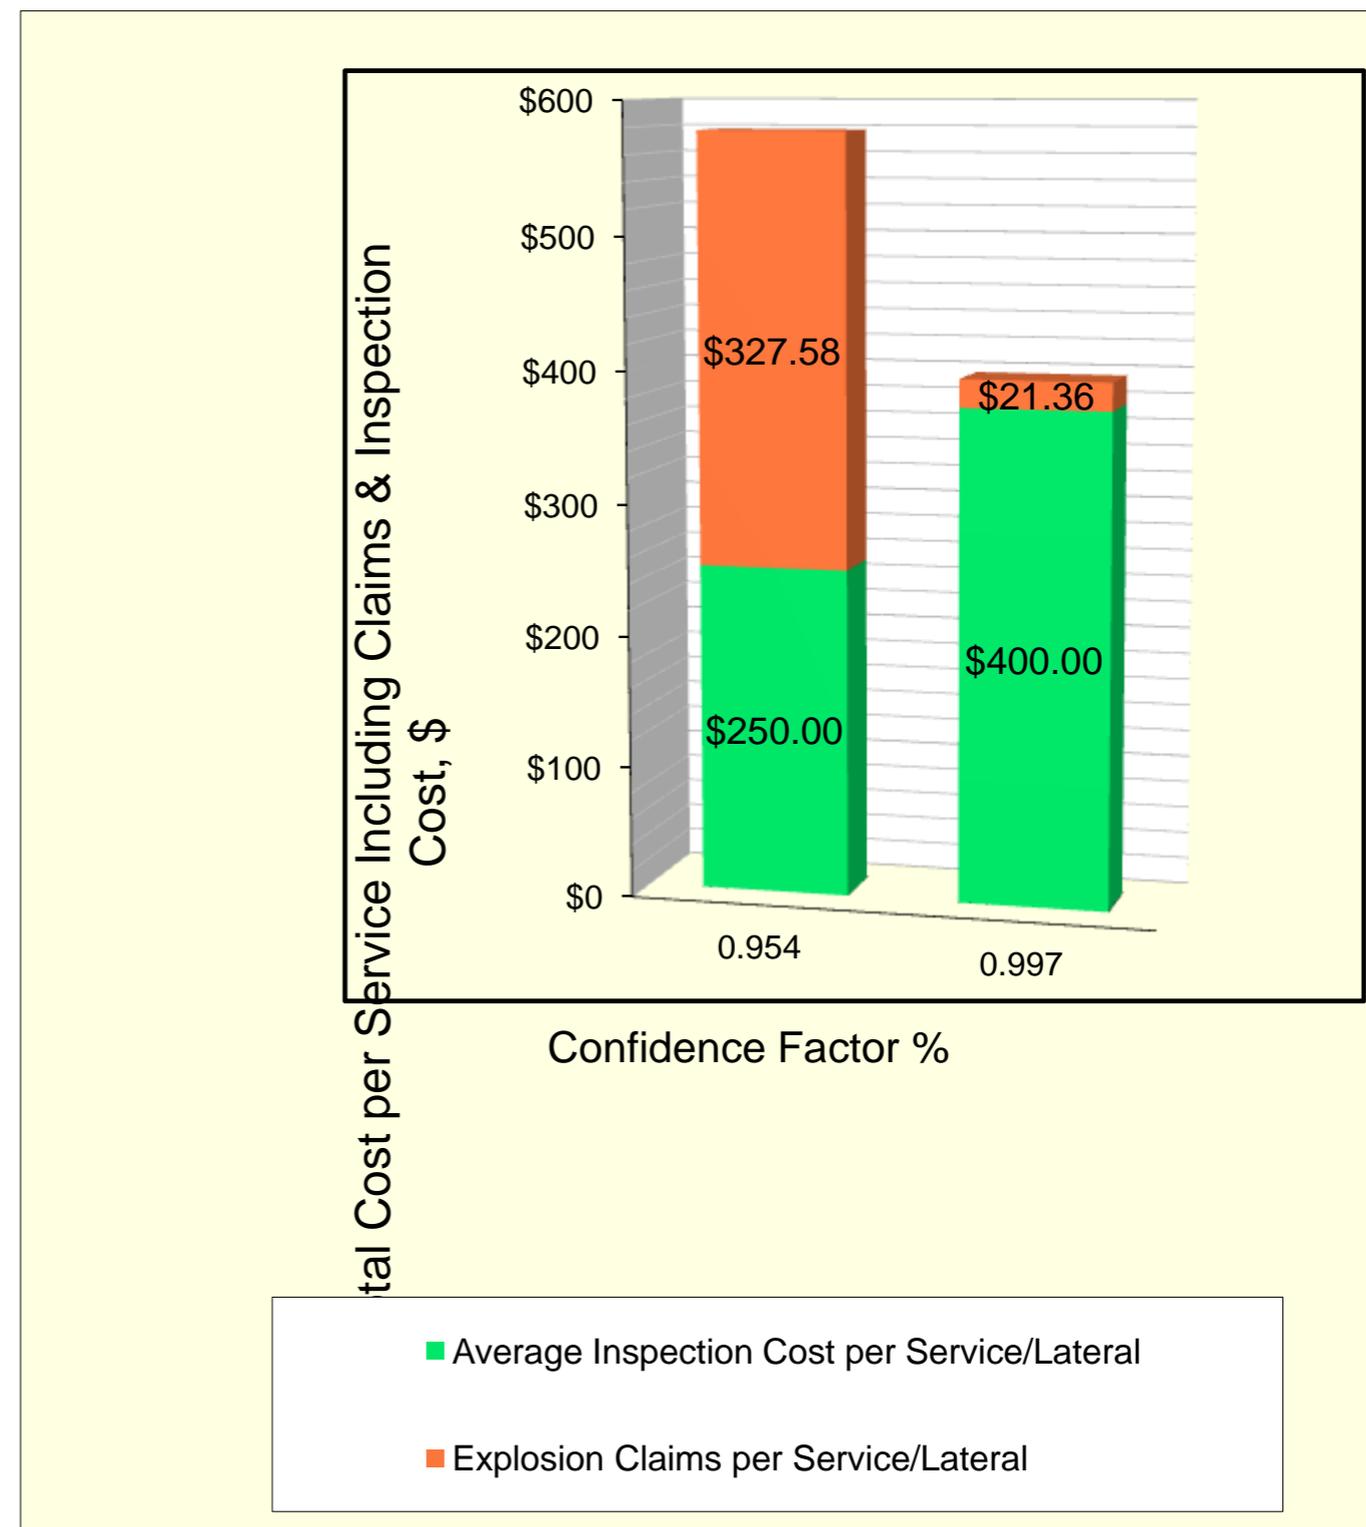
High Confidence Processes Saves \$

- Net cost of high confidence work is less expensive¹.
- Higher percentage of explosions from lower confidence processes.
- Net savings = US\$12 Billion
- Less impact on reputation
- Less impact on regulatory rate making process

Based Upon Total Gas Services in U.S. and Canada = +/- 75,000,000		
Confidence Factor of Locate / Inspection Processes	95.4% (2 σ)	99.7% (3 σ)
Total Cross Bores Expected to be in Project Area	267,000	267,000
Cross Bores Expected to be NOT Found	12,288	796
Cross Bores Not Found & Expected to Result In Explosion Claims, expect 20% <u>will</u> result in explosion.	2458	159
Expected \$ Cost of Cross Bore Explosion Claims	\$24,580,000,000	\$1,590,000,000
Explosion Claims per Total Services in Project Area	\$328	\$21
Avg. Inspection Cost per Lateral Estimated, (Note: excludes program management, scoping, data storage costs – variable as to trenchless usage and sewer configurations)	\$250	\$400
Total Apparent Cost per Service/Lateral	\$578	\$421
Net Cost Savings, 2 σ vs. 3 σ	\$13.6 Billion <u>Savings</u> & <u>Many Lives</u>
