Natural Gas Distribution

Cross Bore Safety

Pipeline Safety Seminar

**By: Mark Bruce, President,
Cross Bore Safety Association**

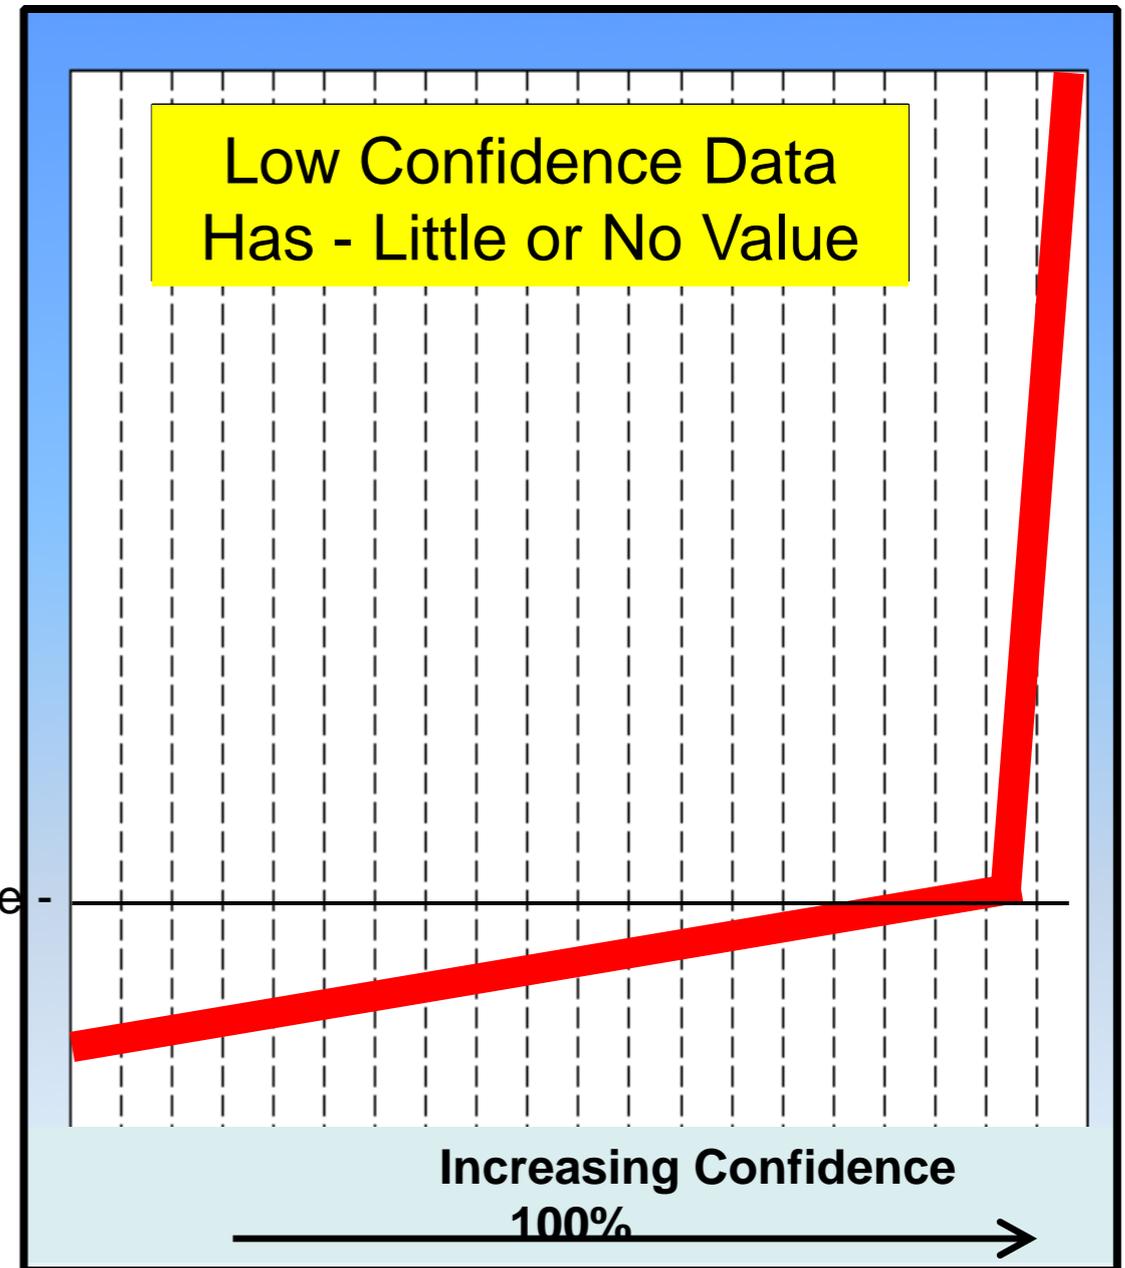
Value Increases with Higher Confidence Processes

- Low confidence results create false security
- Low confidence results may have negative value
- Low quality work may have to be completely reworked.
